## Vaiont slide, Italy, 1963

EOSC 434

## Vaiont: Pre-failure observations

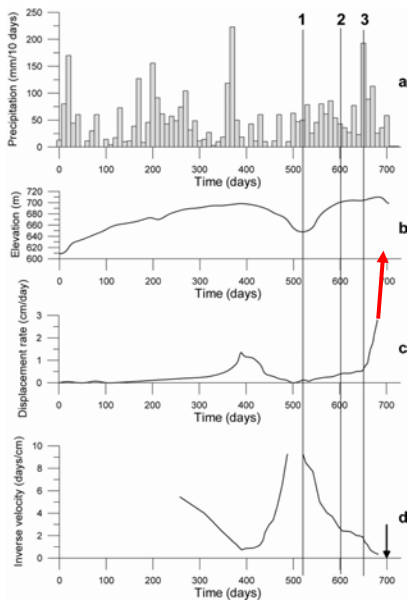
- Slide identified 4 years before failure
- Three acceleration episodes
- Piezo level fluctuated with reservoir
- Potential for brittle (rapid) failure not recognized

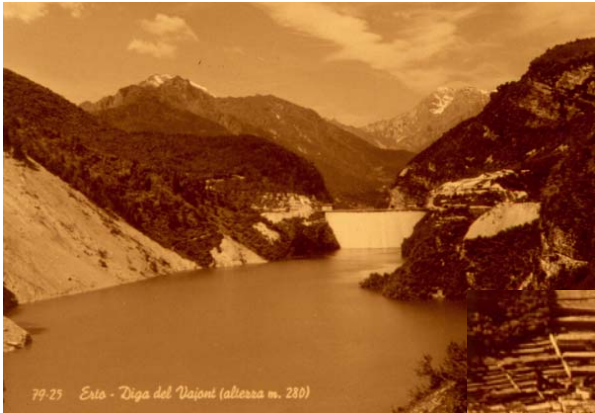
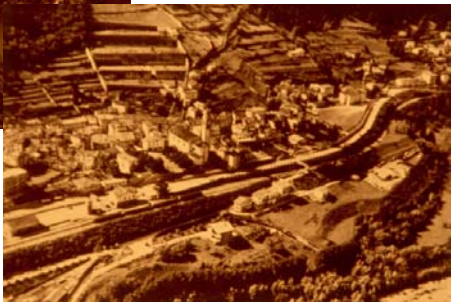
Town of Longarone

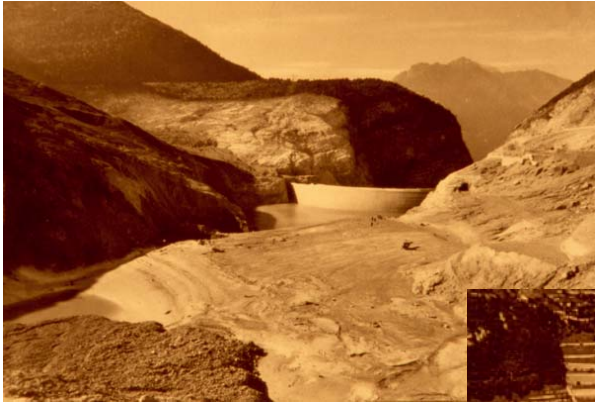
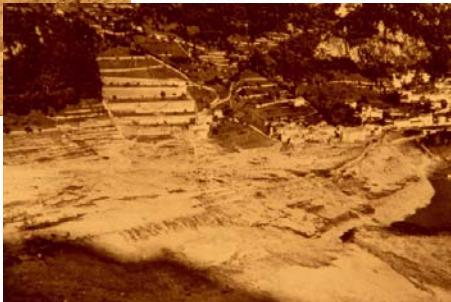
Longarone  
Flooding, over 2000 dead

Town of Longarone

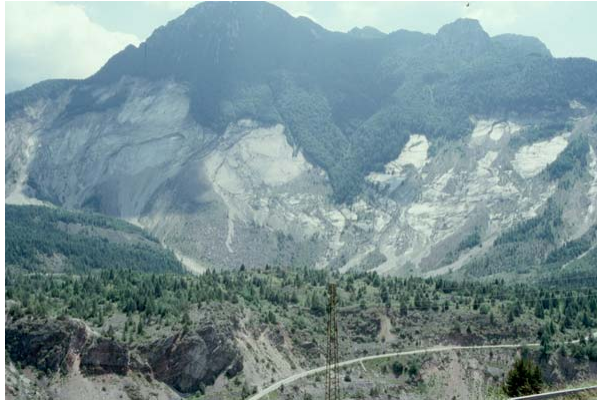
Limestone bedding planes, filled with bentonitic clay, pre-sheared to residual strength. Brittle, extremely rapid failure was probably due to internal shearing of the strong limestone rock mass.

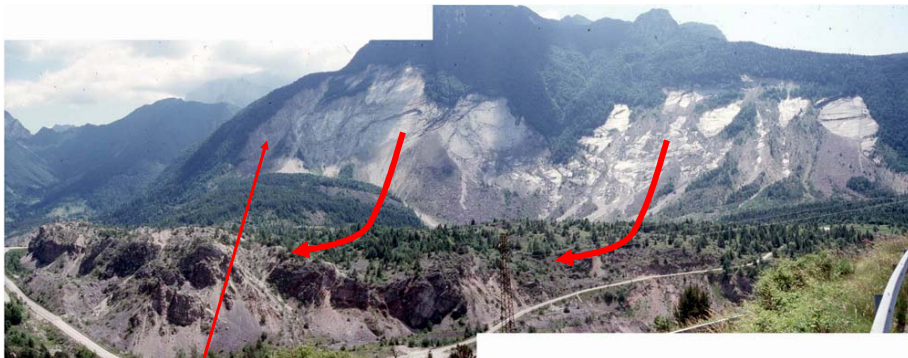
Side  
shear

*Sctn. 2*

Internal shear
