## Landslide and erosion problems in glacio-fluvial soil escarpments, Greater Vancouver

*Oldrich Hungr, Geological Engineering, UBC*

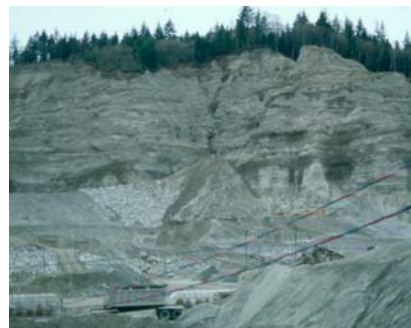
Meltwater deposited large quantities of sand and gravel in front of the glacier fronts. The sand deposits were raised ~100 m high to form glacio-fluvial terraces (“uplands”)

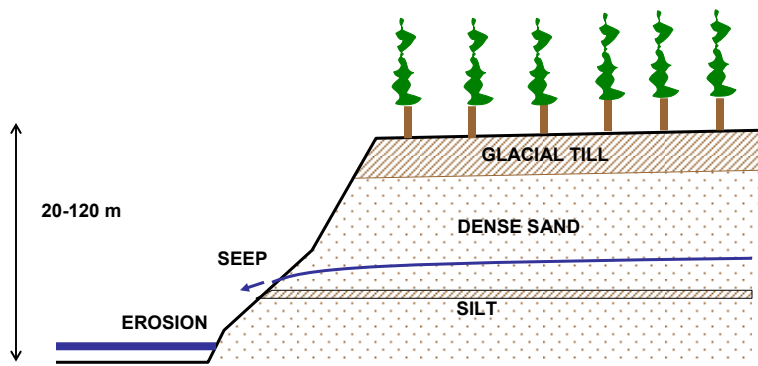
Escarpment: original configuration (active toe erosion)

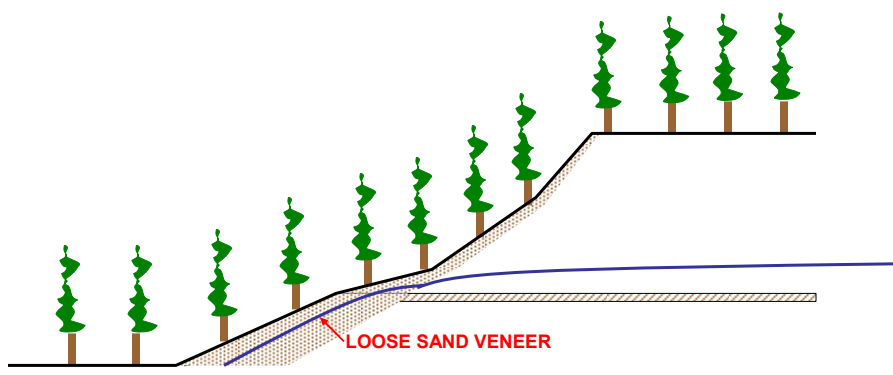
Escarpment: long-term natural slope profile

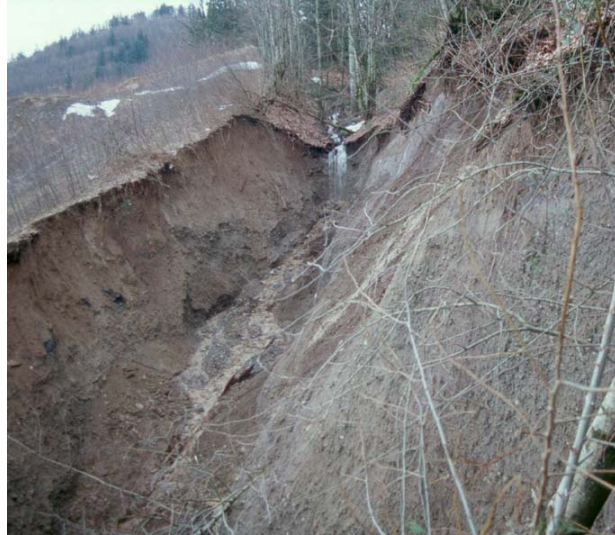
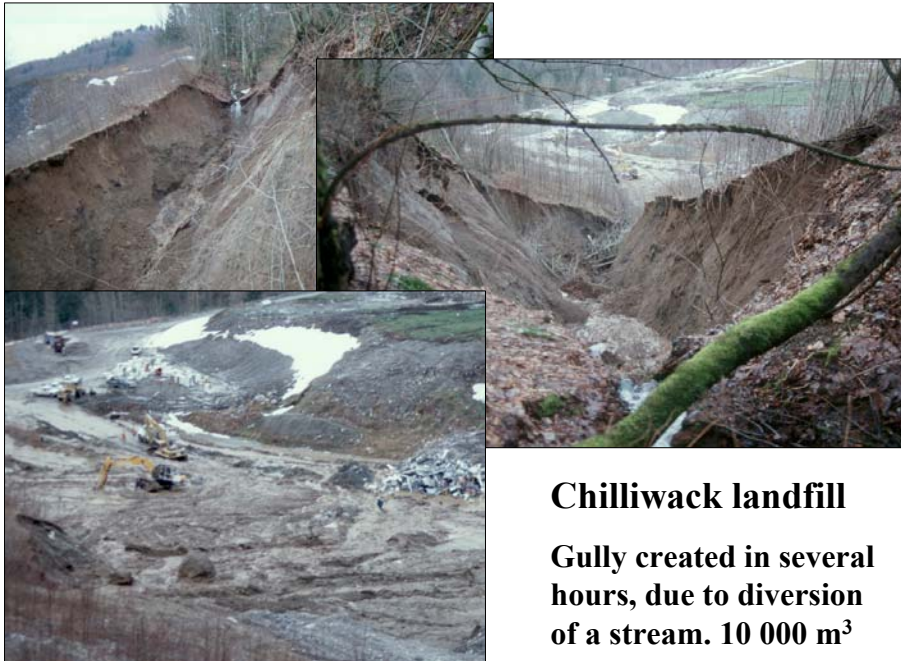
**Chilliwack landfill**

**Gully created in several  
hours, due to diversion  
of a stream. 10 000 m<sup>3</sup>**

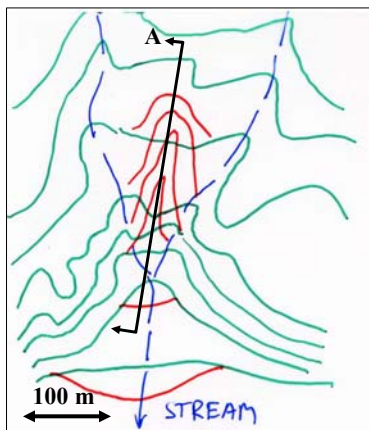
## Coquitlam gravel pits, 1985

20 m contours:  
 before —  
 after 2 days —
